Pro-Tec Inspection Services, Inc.

Sample Report
16500 Selby Ave.
Poolesville, MD 20837.

**16500 Selby Ave.
Poolesville, MD 20837.**

**Prepared for: John Doe
Realtor: Ken Green
ABC Realtors**

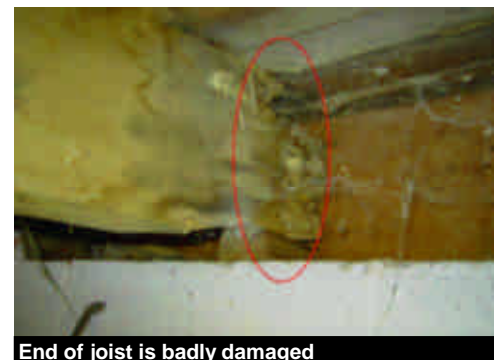
Wood rot was observed in the floor system, Near the exterior door of the screened porch.

End of joist is badly damaged

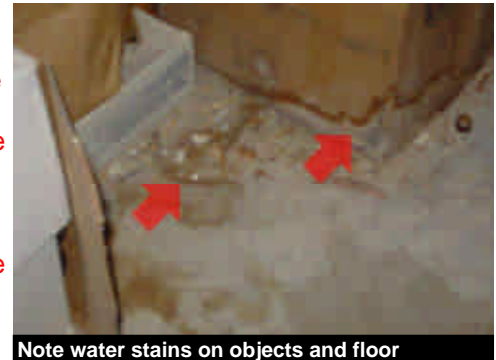
A history of basement dampness was visible at the time of the inspection. While the basement appears dry at the time of the inspection, clogged gutters or downspouts and or a negative grade could result in future dampness. Basement dampness is usually related to water that used to be on the roof. Large volumes of water come off of the roof to concentrated areas. When these areas are saturated the hydrostatic pressure forces its way through the path of least resistance, usually the basement. Most basement water problems can be solved for a relatively low cost by simply cleaning the gutters and directing the downspouts away from the house. That being said, if the water then runs back toward the the foundation regrading is needed. We recommend a gentle 1" per foot grade slope away from the home at least 6' using a dense clay type soil.

Note water stains on objects and floor

If the problem persists, the ground is probably saturated and the next step is a french drain and sump pump. While this is sometimes needed, it is advisable to start with the least expensive and work backwards until the problem is solved.

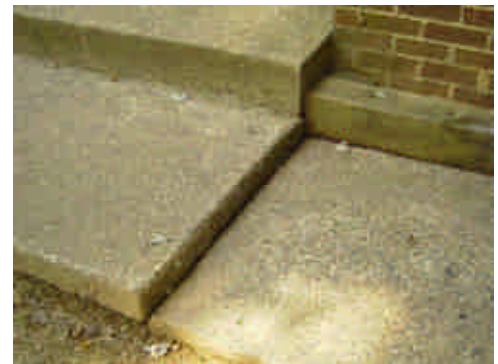
CONDITION: Uneven settlement of sidewalk resulting in a tripping hazard.

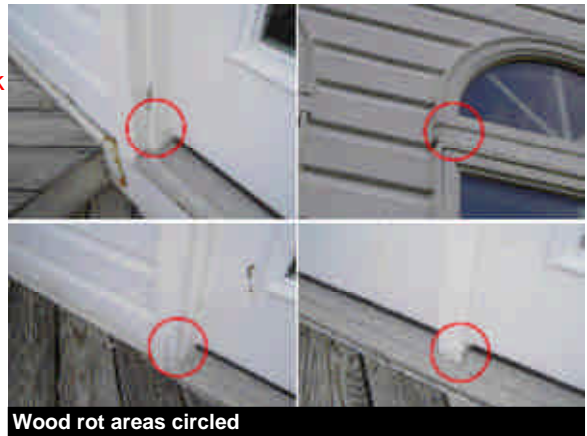
Caulking, Paint/finish needed, Moisture stains/rot noted in several trim boards on the back side of the home. A board-by-board search was not performed and is beyond the scope of this inspection.

Wood rot areas circled

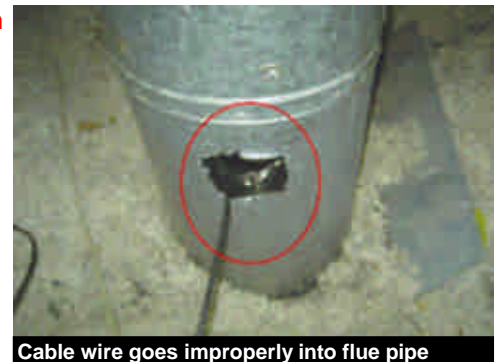
The chimney for the fireplace has been improperly cut in the attic and downstairs wall so that wires can be fished through the pipe. This is an extremely dangerous situation that will require repair before the chimney is used. Starting a fire even once is likely to result the house burning down.

Cable wire goes improperly into flue pipe

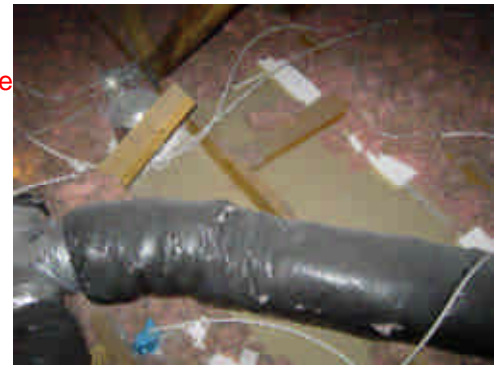
R-30 is the amount of insulation recommended for this region.
Insulation is missing in some areas. We recommend adding where needed.

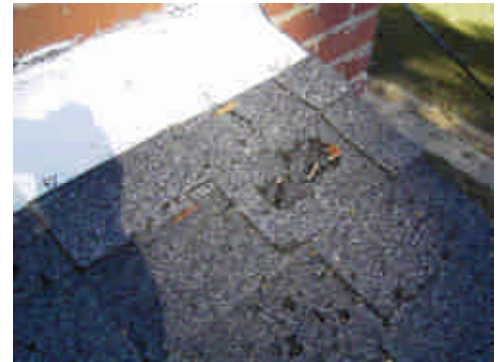
There is an old porch roof in back that is in need of replacement. Leaks are certain.

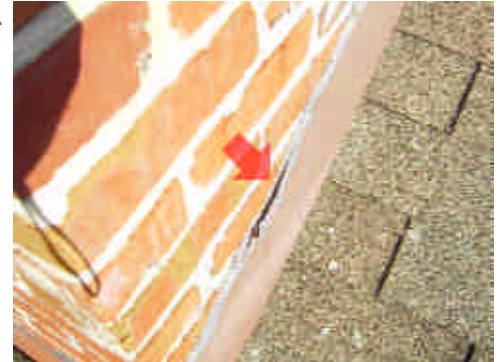
CONDITION: The potential for water entry is present.
Reseal at the chimney.

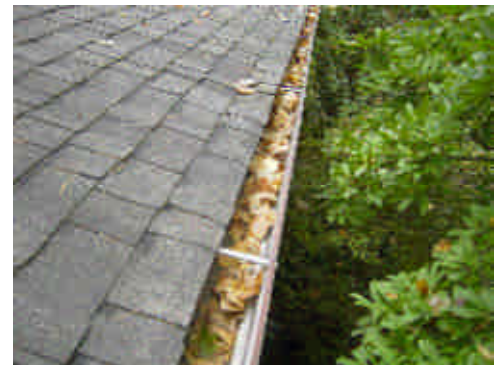
CONDITION: Debris in gutter, recommend cleaning.

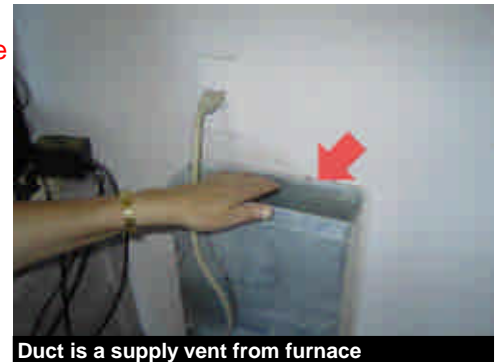
Repair any openings with approved materials to restore its fire rating. There is an air duct that is extended into the garage. It is an unsafe condition that could allow CO gas to get into the home. We strongly recommend repair.

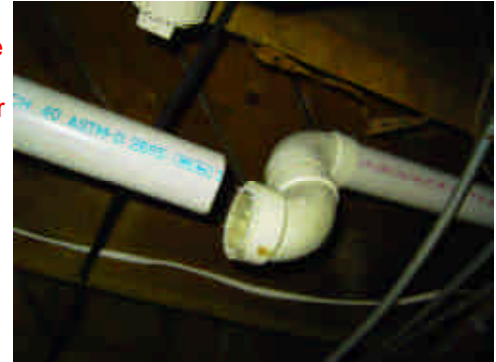
CONDITION: Disconnected waste line in the basement under the kitchen. It must be a vent pipe as no water leaked out when the fixtures were tested, however it still needs to be reconnected.

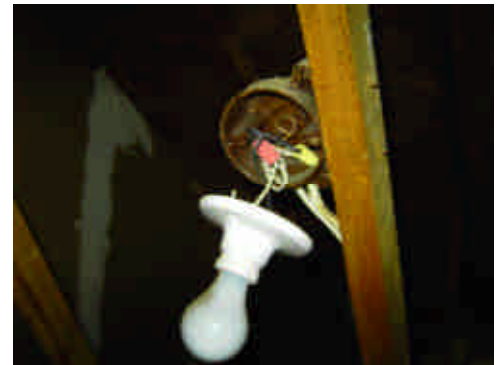
Lights are not operational in some areas, possibly due to bad bulbs, recommend having all operating for your final walkthrough to verify proper operation.

Loose light fixture noted in the attic.

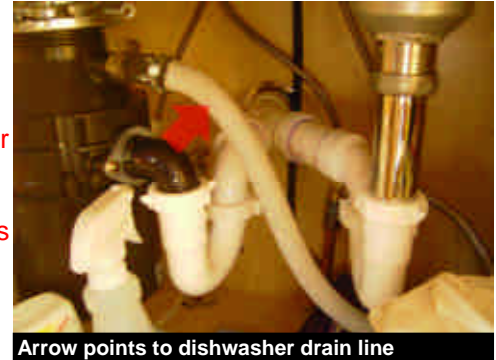
Appears serviceable, Recent model unit, 1-3 years of age, **The dishwasher drain line is incorrectly installed. It should extend as high as possible under the counter to prevent grey water from entering the dishwasher in the event of a backup in the sink. Incorrect installation is a common problem that is easily corrected.**

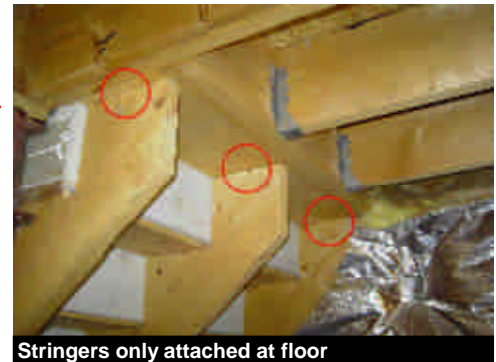
Improvement needed to stairs and/or handrail(s), Stairs poorly designed and unsafe. The top of the stringers is not adequately secured and may fail under heavy load. Additional supports are recommended at this time.

Stringers only attached at floor
