12/4/09  
Sample Infrared Report  
123 Main Street  
Rockville, MD

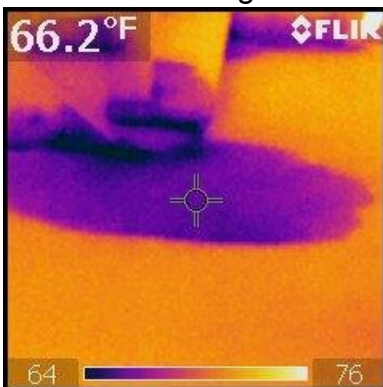
The basement water leakage is an active leak that extends out from the lower left corner of the basement near the furnace room out into the room about 6 feet. The wet area also extend up the drywall about one foot. The dark areas in the left image indicate wet areas.

Lift the wet areas of the carpeting and padding. Run fans both above and below the carpet to dry it out. Since the leak is fresh if the carpet is dried quickly there should not be any mold concerns. As for the wall that is wet, we recommend cutting a small hole and running a fan and dehumidifier to remove the moisture from the wall area as quickly as possible.

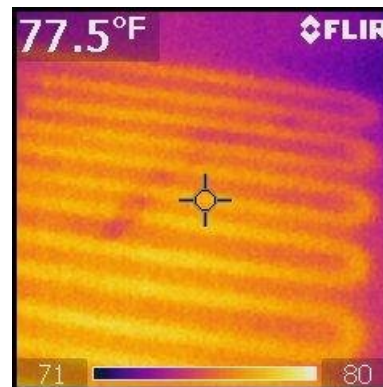
The radiant heat was observed in the family room using an infrared camera. That area showed that the underslab heating system is operating as designed.
