INSPECTION REPORT

123 Sample report.
Potomac MD 20854.

Prepared for:
John Smith

Inspector of record: Rob Hopkin
ASHI # 32081
MD License # 29455

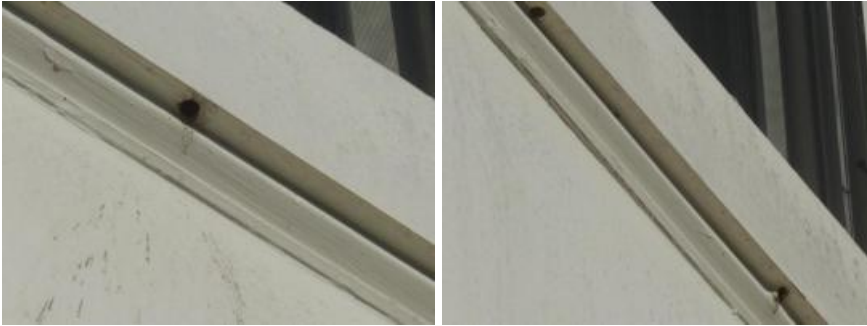
Carpenter bee damage observed in the wood trim over the back deck area. Damage is minor, but watch for the bees to come back in the spring if they have not treated. Ask if they have any paperwork indicating treatment in the past.

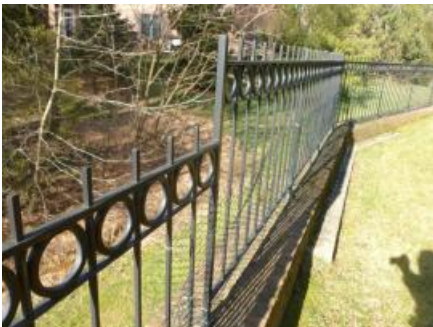
CONDITION: Fence is loose on the back retaining wall.

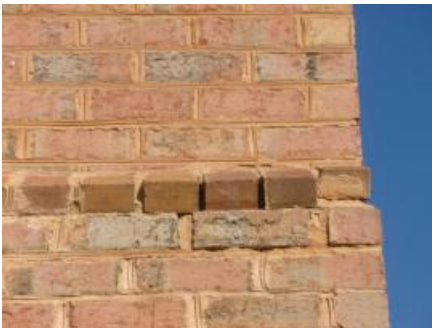
BRICK CHIMNEY: Missing bricks and mortar at the left side fireplace where it narrows.

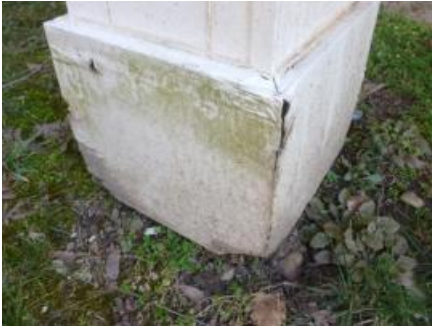
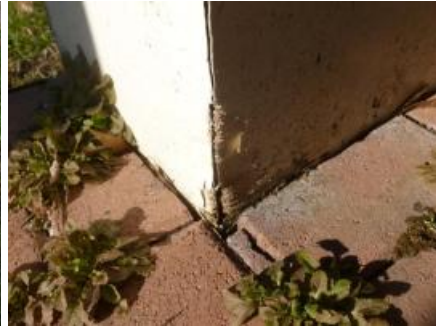
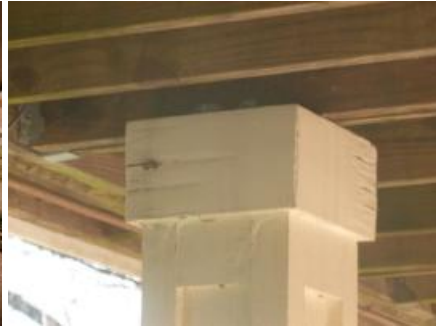
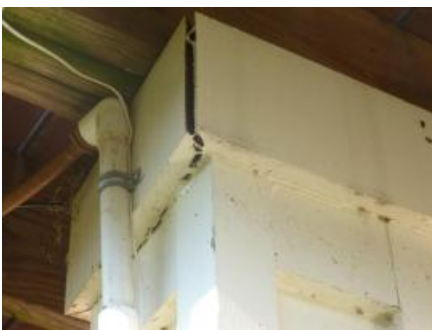
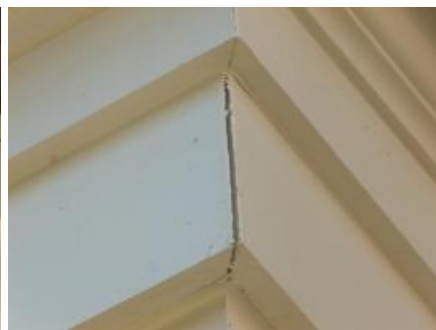
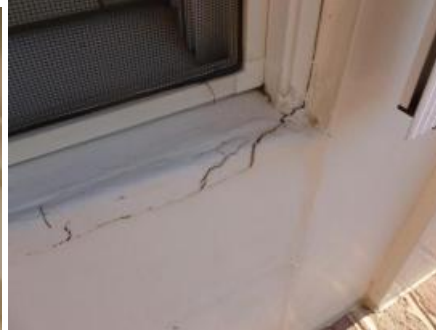
Rot in some of the deck columns.

Minor wood rot observed in the back window frame of the family room window.

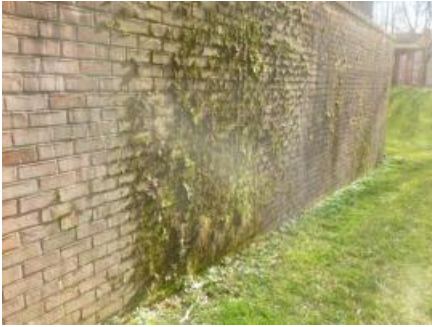
Appears serviceable.

Recommend killing moss on the retaining wall.

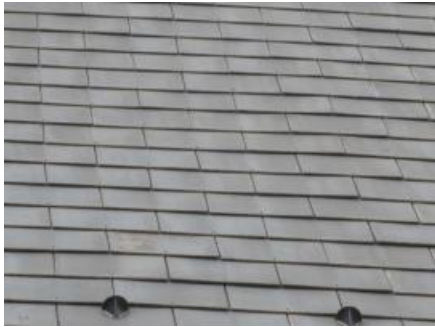
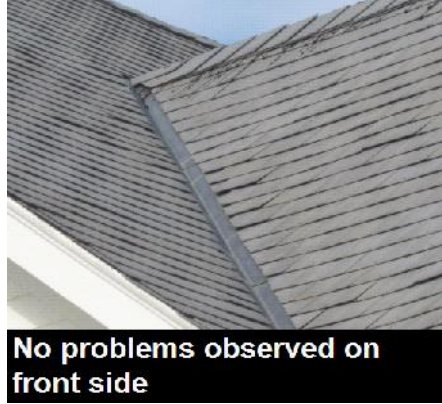
Concrete tile roof. This type of roof was projected to last in excess of 40 years, but we are seeing problems with product failure as soon as 10 years. Several of your neighbors have had to make repairs and your roof needs minor repair at this time. Budget to have some tiles repaired every few years.

Estimated remaining life 10-15 years with repair.

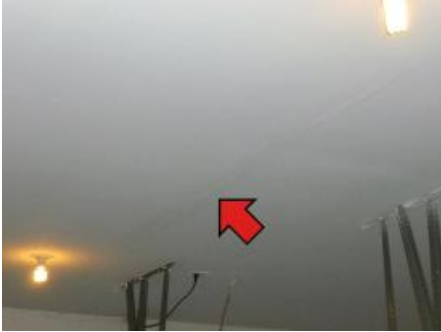
Water stain on the ceiling tested dry with a moisture meter at the time of the inspection. There does not appear to be a reason for the stain. Monitor for future leakage, but we doubt it will leak again.

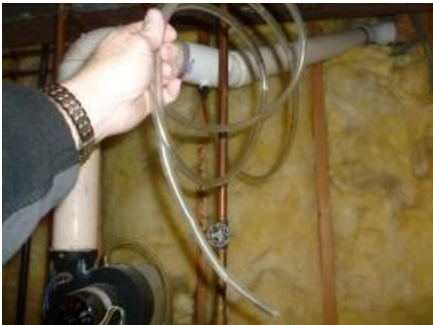
Furnace room.
Operating with no sign of leakage. The waterheater appears to be an older model. Any waterheater over 7 years of age has the potential for failure at any time. That being said, some may last for 20 years or more, thus unless the waterheater is located in an area that will cause significant damage when it fails most people change the waterheater when it begins to leak or develops other problems to expensive to warrant repair.

[Waterheater condensate line should go into a drain or outside.](#)

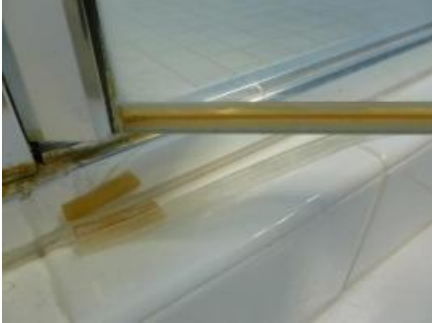
- OVERALL CONDITION:** The general condition of the baths on the whole is good. As with most homes there are a few repairs needed at this time.
- BASEMENT BATH:** [Leak at the cold side faucet.](#)
- POWDER ROOM BATH:** [Faucet is a little loose.](#)
- HALL BATH:** [Fan is not operational.](#)
- MASTER BATH:** [Gasket falling off the shower door and the door rubs against the frame.](#)

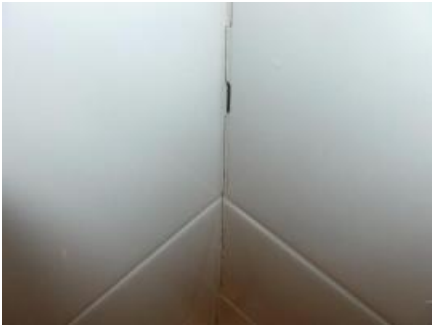
Sink faucet is missing the aerator.
Recommend caulking around the tub/shower area.

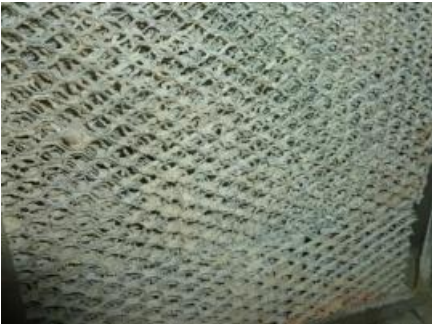
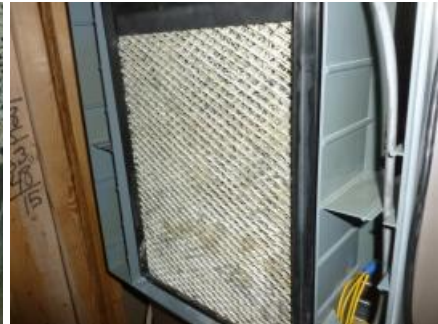
Operational.
Honeywell humidifier right of the furnace is not operational.

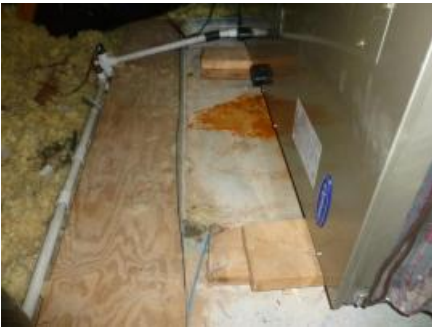
Evidence of leakage into the backup pan of the attic unit. Recommend further evaluation this summer when the AC is running and condensation is happening at or monitor for future leaks.

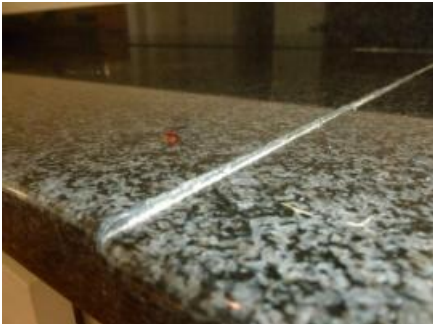
Granite countertops. This is a popular high end product that lasts a long time and looks great. It can stain, crack, scratch or get chipped if not properly cared for. **Reseal the granite every year or 2.**
Uneven counter **top left of the main kitchen sink.**

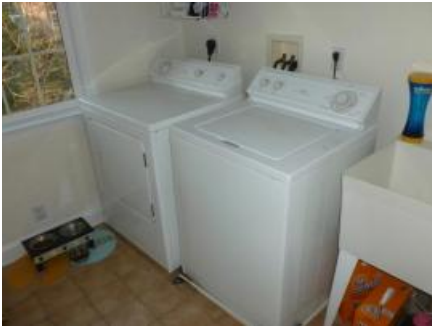
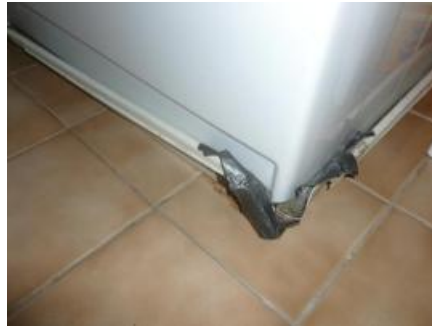
- DISPOSAL:** Operational.
- DISHWASHER:** Operational as tested.
- STOVE/OVEN:** Gas, Cooktop, Electric, Double ovens.
Operational as tested.
- HOOD/VENTILATION:** The stove area is equipped with a down draft exhaust system that appears to go outside.
- REFRIGERATOR:** General condition, The unit appears to be operating normally at the time of the inspection. Freezer temperatures were observed below freezing and the refrigerator was cold. The refrigerator is equipped with an ice maker. Ice makers generally break and need repair long before the refrigerator needs replacement.
- MICROWAVE:** Operational.
- WASHER AND DRYER:**
- CLOTHES WASHER:** Operational in mode tested. [Recommend replacement of the damaged pan and leveling the unit.](#)

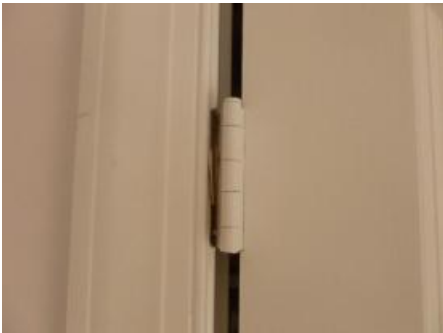
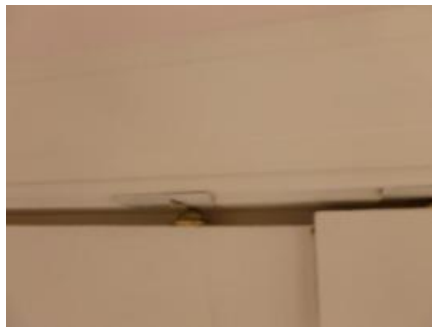
[Normal minor adjustments needed for proper operation at the master bedroom door.](#)

[Missing hardware on some doors. Examples: front right bedroom closet door, main floor hallway closet door.](#)

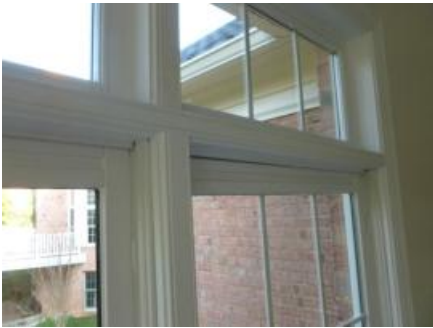
Some windows are sticking and hard to open or could not be opened at all marked by blue tape. This is a common problem especially when windows are not operated frequently or the inspection is conducted in humid conditions. 8-10

Study right side windows not fitting tightly. The opening or the windows are not installed level. We recommend additional weatherstripping to seal any air leaks.

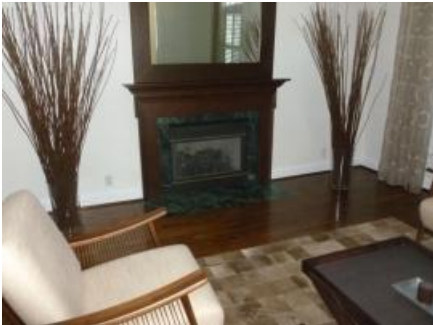
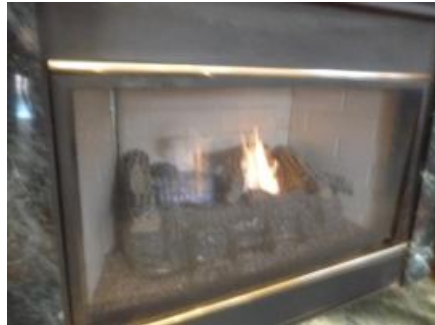
TYPE OF DEVICE INSTALLED: Masonry, Ventless gas fireplaces. Some states will not allow this type of fireplace due to the danger of CO poisoning. At a minimum have a CO detector installed in the room. Most manufacturers instructions on use include opening a window at least 4" and not using it for more than 2 hours at a time and that they be installed in a large room. We do not recommend using it at all.

Gas smell coming from the fireplace in the basement. Recommend further evaluation and repairs done as needed. We were unable to get the unit to operate in the family room.
