INSPECTION REPORT

123 Sample report.
Potomac MD 20854.

Prepared for:
John Smith

Inspector of record: Rob Hopkin
ASHI # 32081
MD License # 29455

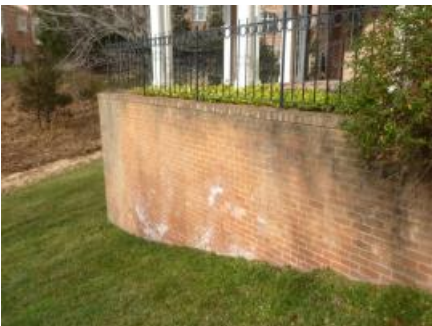
Appears serviceable.

Recommend killing moss on the retaining wall.

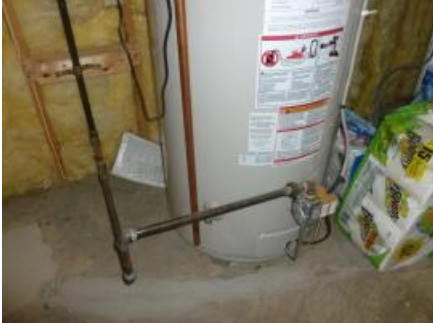
Furnace room.
Operating with no sign of leakage. The waterheater appears to be an older model. Any waterheater over 7 years of age has the potential for failure at any time. That being said, some may last for 20 years or more, thus unless the waterheater is located in an area that will cause significant damage when it fails most people change the waterheater when it begins to leak or develops other problems to expensive to warrant repair.

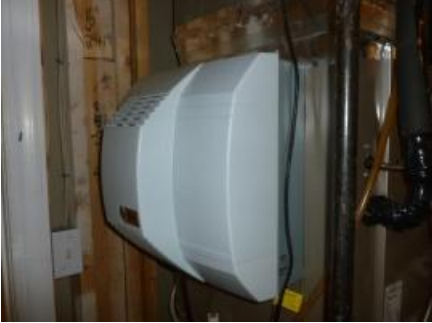
Operational.
Honeywell humidifier right of the furnace is not operational.

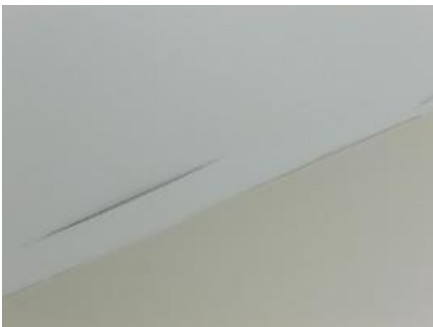
General condition appears normal for the age of the building. Some minor nail pops and drywall cracks need repair in most homes.
